Generation and its control of impact sound by stick-slip phenomenon in buildings

- (1) Property of impact sound and vibration -

Yasuaki Hayashi^{a)}

Hidemaro Shimoda^{b)}

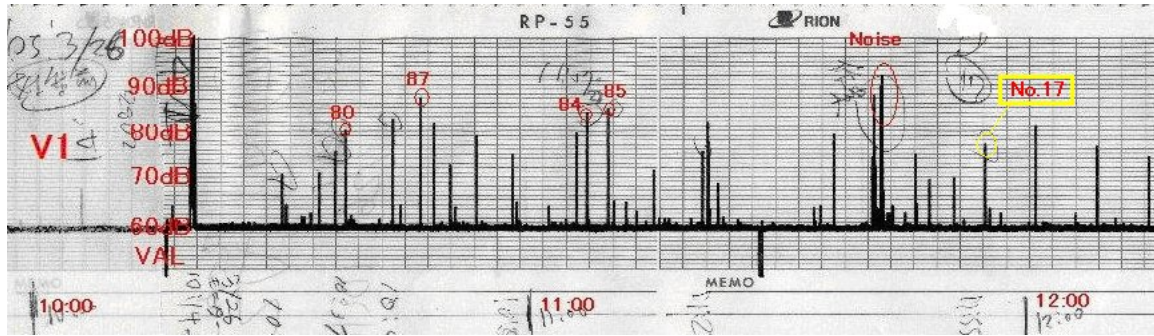
Fig. 2 – Observed vibration level.

This sound was being generated frequently in several rooms in the upper floors of the high-rise apartment building. It occurred when the largest number of vibrations was more than 30 times a day at its peak. The biggest sound level was 72dB A-scale (vibration acceleration level 96dB) in the room. The Table 1 shows the measurements of the sound and vibration and the frequency characteristics can be seen in the graphs (Fig. 3, Fig. 4).

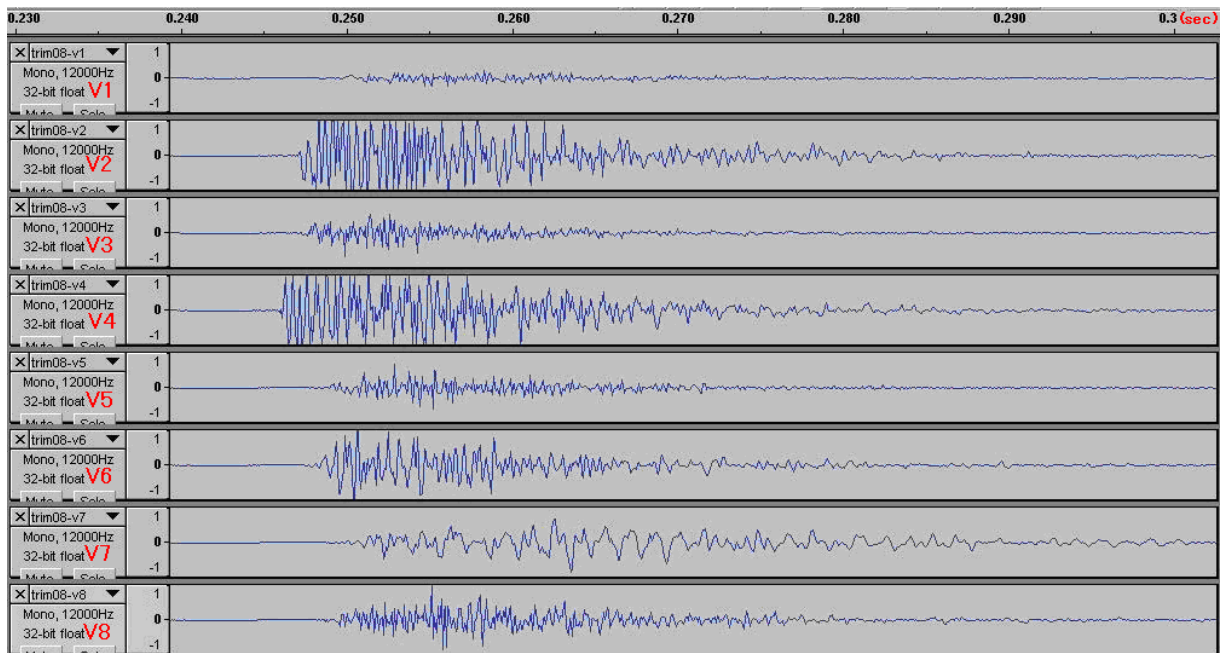
Fig. 5 – Example of observed phase difference in vibration-wave forms.

The vibration accelerometers were arranged in two-dimensional distribution on the floor slab. We could calculate the occurrence of vibration from the phase differences between the wave forms of the observed vibrations. We show the estimated position in Fig.7. That position is near an outside beam joint where we found a tiny crack. A part of the verandah beam (6m in length, 5t in weight) was not fixed completely (Fig. 7). We have judged that the contact points of the beam joints continue to expand and contract with changes in temperature.

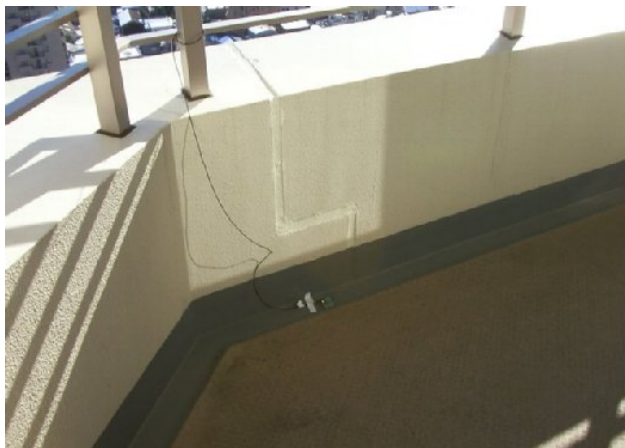
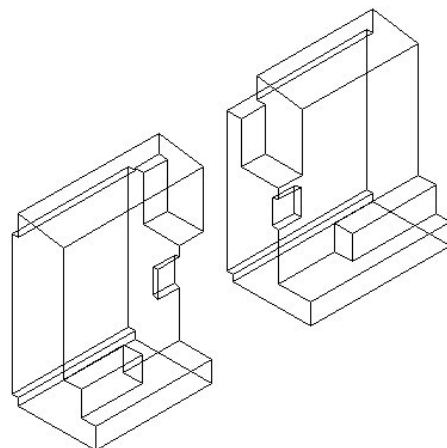
Fig. 7 – The joint area of the beam.

The beam joint is vertically connected by a metal plate and bolt in two places. The metal plate was too weak so that the beam itself moved. Due to thermal stress, slip occurs at the contact surface of the concrete structure. We found that the shock wave was generated by this stick-slip phenomenon.

In a technical study we bonded the beam joint with a liquid epoxy resin injection and we filled the gap in the beam with grout. This procedure was repeated in more than 100 locations.

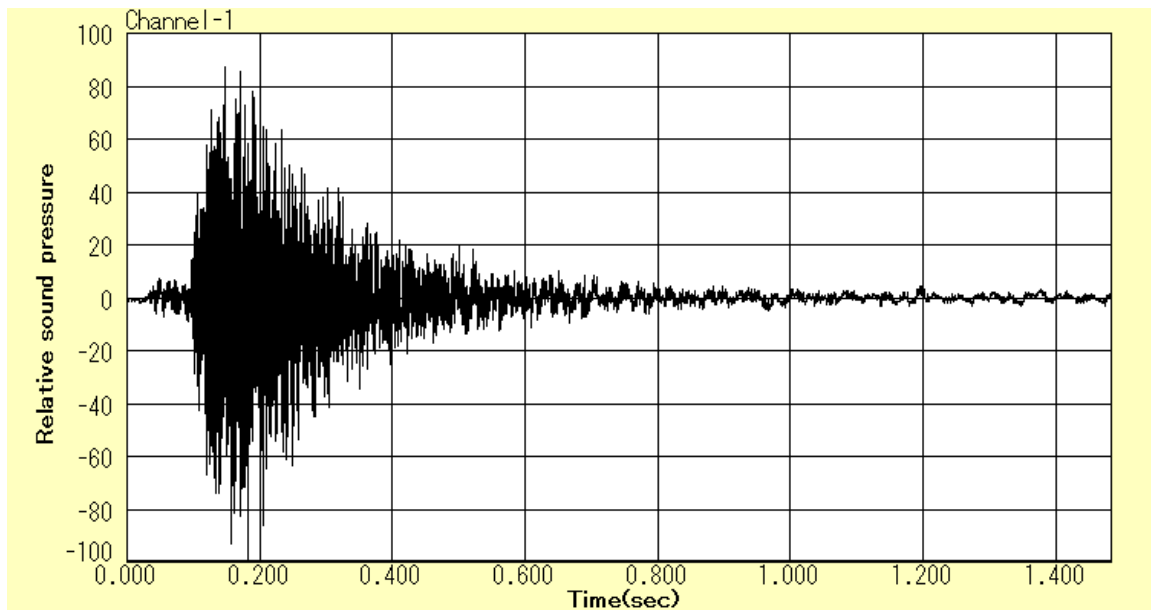
Fig. 8 – Impact sound-wave form.

The sound waveform had a uniform level of frequencies from low to high which is the nature of the impulse (Fig. 8, Fig. 9).

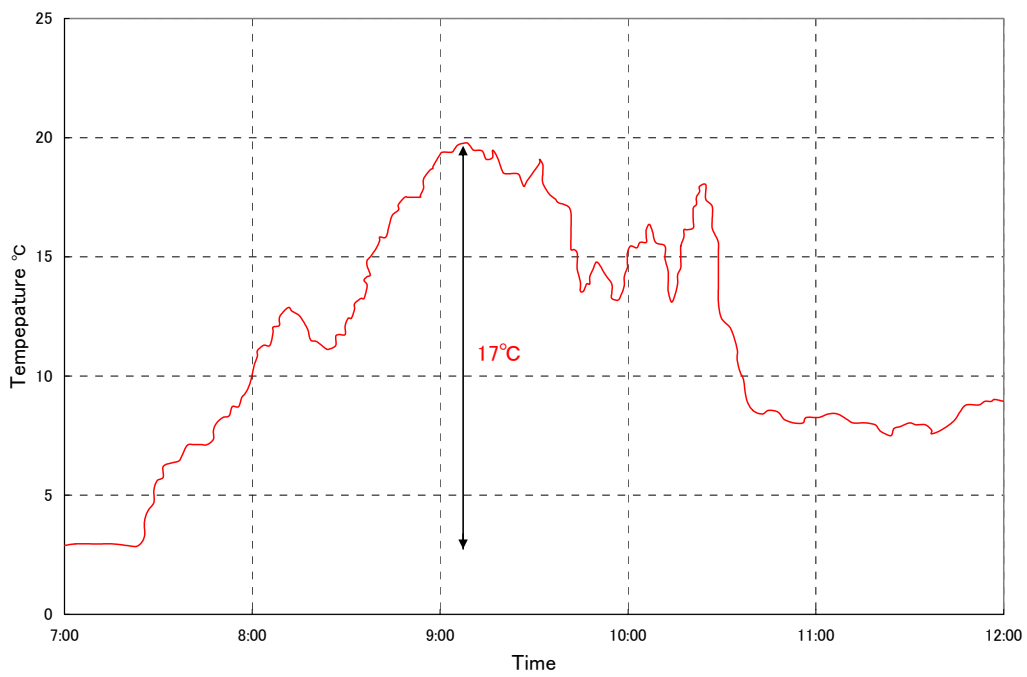
Fig. 11 – Temperatur of outside.

The coefficient of thermal expansion of steel and concrete is approximately equal (about $1 \times 10^{-5} / \text{K}$)³. Therefore a 6 meter precast concrete beam will move about 1 millimeter with a 17°C shift. Fig. 11 shows the rapid change in temperature due to sunshine on the verandah.

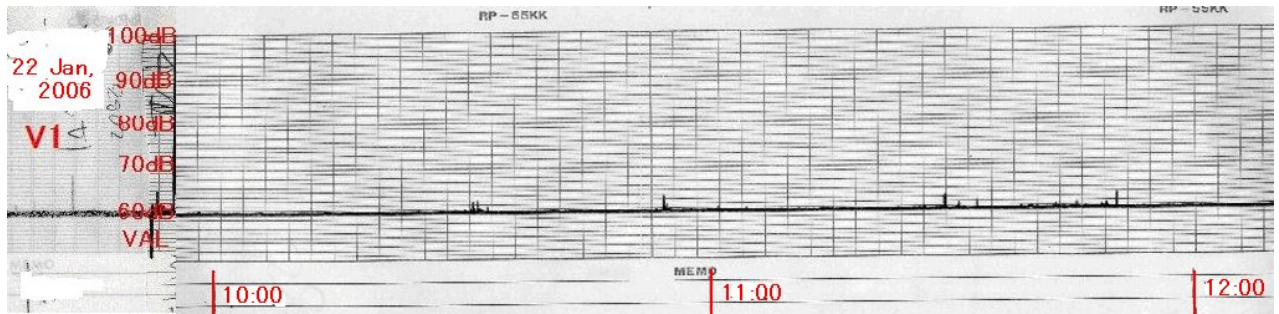
Fig. 12 – Vibration level chart. (after repairing)

As a result, the joints were fully integrated and the impact sound has not re-occurred since then. Even after the Great East Japan Earthquake last March there has been no report of the re-occurrence of impact sound, we are convinced of the effectiveness of this repair method.
