Generation and its control of impact sound by stick-slip phenomenon in buildings

- (1) Property of impact sound and vibration -

Yasuaki Hayashi^{a)}

Hidemaro Shimoda^{b)}

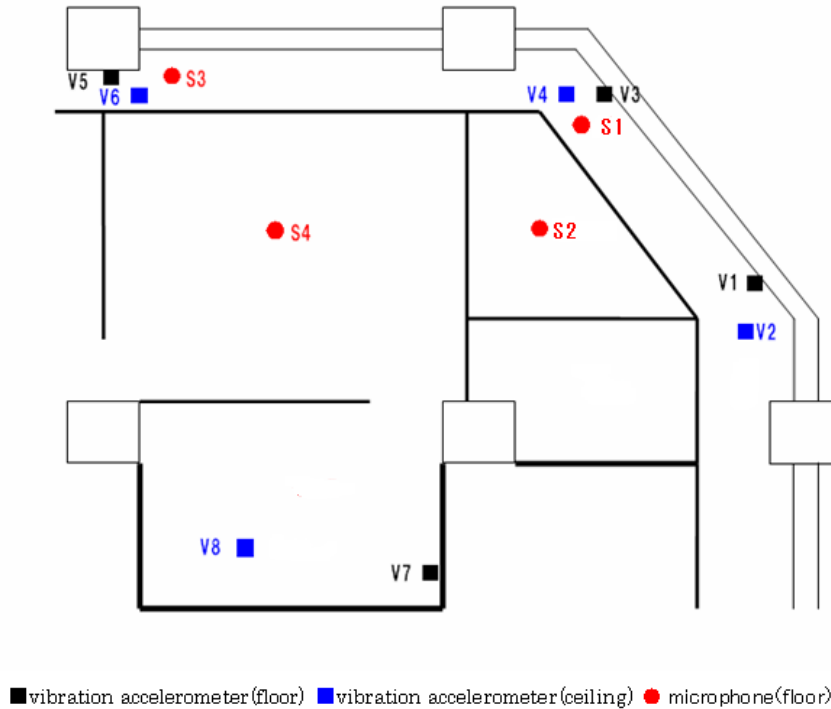
Fig. 1 – Measurement points.

In the case of solid-borne sound it is difficult to determine the direction of the sound by just measuring it. Therefore, in order to identify the source of the vibration in a plane slab we focused on the vibration-wave form (phase), which was being generated from an unknown source and then propagated in the building frame. We indicate the measurement location in Fig. 1.
